Manhole Inspection Summary

Manhole # S45I__048MH

Insp Date: **4/25/08 8:56 AM**

Location Address: **1813 s dutham st**

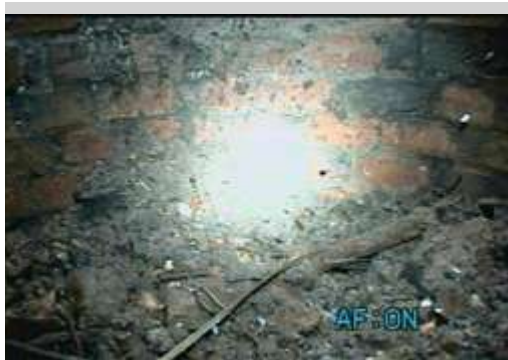
Defect 4

Condition: ☐ Sound ☐ Cracked ☐ Root Intrusion ☐ Deteriorated ☐ Leaks ☒ **Debris**

channel debris

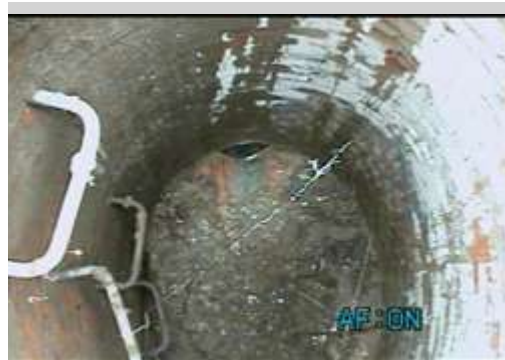
Defect 3

Condition: ☐ Sound ☐ Cracked ☐ Root Intrusion ☒ **Loose Brick** ☐ Deteriorated

Infiltration: ☐ None ☐ Joint ☐ Cracks ☐ Mortar ☐ Roots ☒ **Wall**

Barrel Loose Bricks with flow from wall

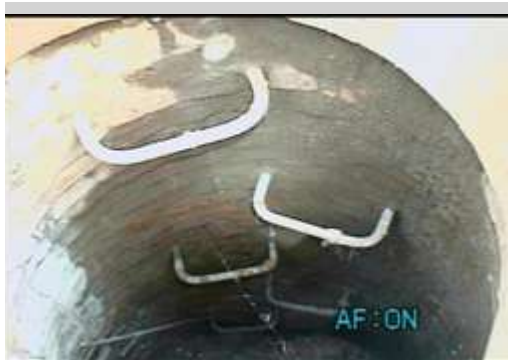
Defect 2

Condition: ☐ Sound ☐ Cracked ☐ Root Intrusion ☒ **Loose Brick** ☒ **Deteriorated**

Infiltration: ☐ None ☐ Joint ☐ Cracks ☐ Mortar ☐ Roots ☒ **Wall**

Count: **5** Missing: **0** ☒ **Corroded**

corroded stairs, corbel deteriorated & loose bricks with flow from wall

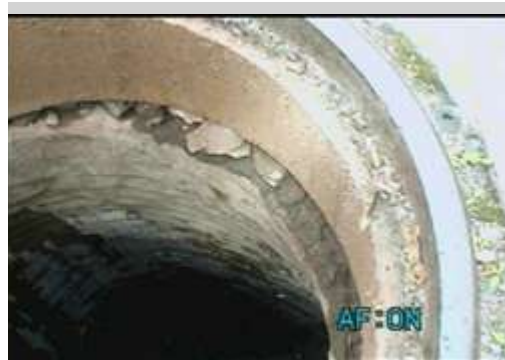
Defect 1

Offset: **2** (in.)

off set frame
